SKINT WATER SERIES

SUSTAINABLE URBAN WATER PLANNING ACROSS BOUNDARIES

FLOOD ALLEVIATION AT DEVONSHIRE PARK AND MAYFIELD ROAD, BRADFORD, WEST YORKSHIRE, ENGLAND

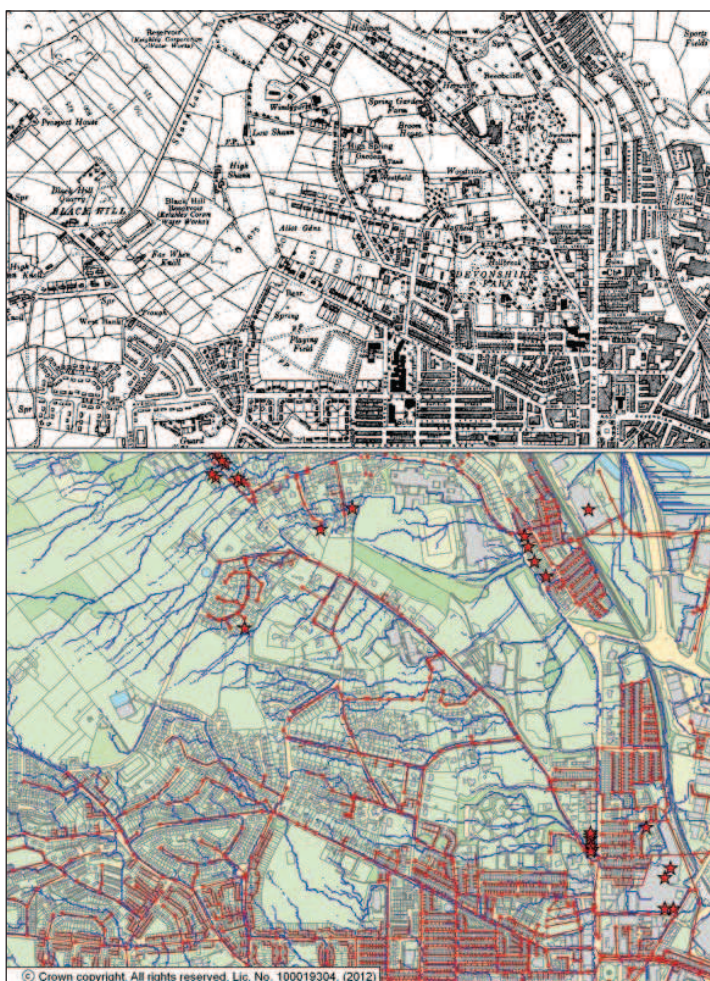
FIGURE 5. STUDY AREA AROUND 1960 AND IN 2000

Figure 5 shows that in the 1960s the area to the north and west of Devonshire Park was largely farmland with some areas of predominantly low-density housing. During the intervening period, much of the farmland has been developed, mainly with medium-density housing, and a school has also been constructed

There has been a significant amount of development within the catchment since the 1960s. This is illustrated in Figure 5.

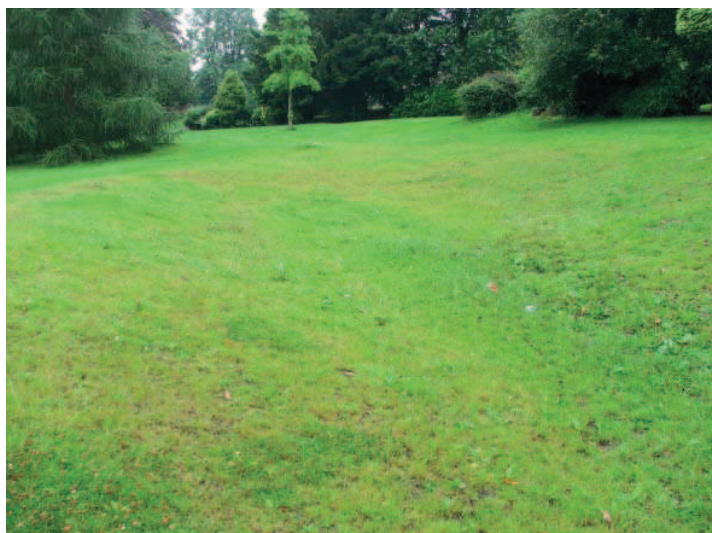
FIGURE 6. TRENCH-TROUGH SYSTEM OR “WADI” IN DEVONSHIRE PARK

Storage in the form of SUDS was provided in Devonshire Park using a series of “trench-trough” structures (known as Mulde Rigole in Germany and wadis in the Netherlands, where they are widely used); see Figure 6. These take the form of troughs or depressions (swales), with gently sloping sides, set over trenches containing underground infiltration tanks or infiltration trenches with high void space.

The water from the troughs percolates into the infiltration tanks which are protected from sediment by a geotextile layer. The infiltration tanks provide subsurface land drainage to the troughs, thus improving their performance and reducing the general water logging of the ground that used to occur. Ground profiles were managed to direct the majority of flows into the trench troughs, and residual flows are collected in swales which are also connected to the drainage system. Controlled discharge from the infiltration tank units is directed to the drainage system in the park.

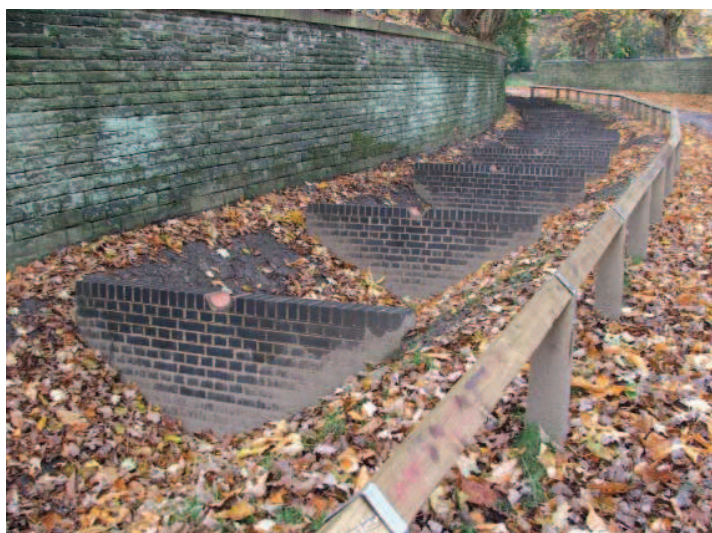
FIGURE 7. COMPLETED STEPPED TRENCH SYSTEM ON MAYFIELD ROAD

A stepped trench system was constructed on land owned by the City of Bradford MDC on the south verge of Mayfield Road with a capacity for 110 m³ storage. There is an option for another trench on the northern verge should this be required. Although benign with respect to the local environment, the trench-trough system on Mayfield Road is striking and brings attention to the drainage works that were undertaken in the area. The wadis in Devonshire Park look much like depressions in the landscape, and they neither add to nor detract from the previous aesthetics of the grassed parkland which existed previously.
